SAFETY ALERT

Modifications of Tractor Units into Tipper Trucks

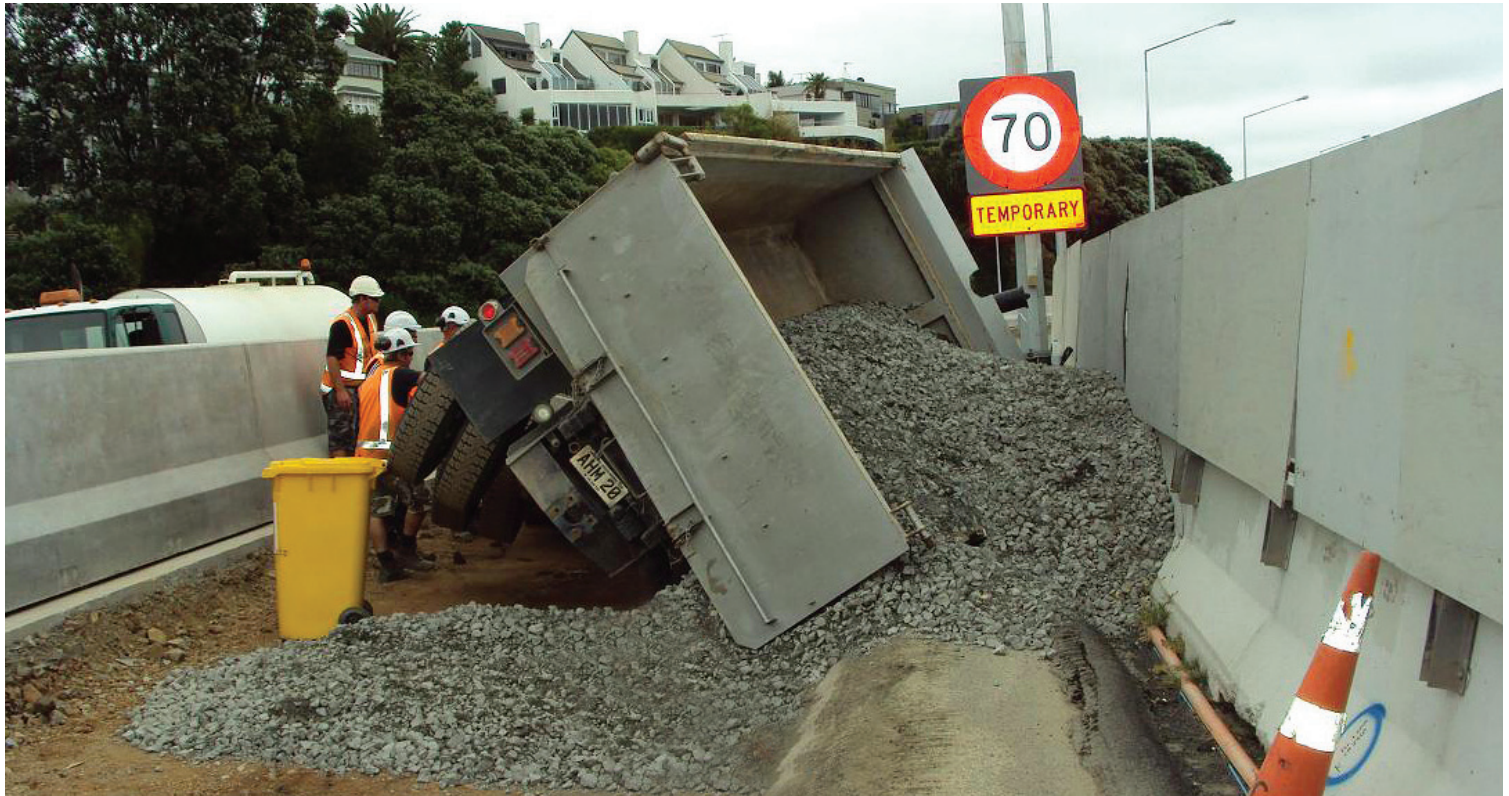
Recently at the Victoria Park Alliance project, a truck loaded with AP65 tipped over while getting ready to start spreading the material. As the truck raised its hoist into position to start spreading, the chassis cracked in between the second and third axle on the right side causing the deck to fall to the right.

- Owners of tipper trucks that have been modified from tractor units are advised to check the rear axle to ensure that the chassis is double skinned the full length of the chassis and not only to the second axle.
- It is advised that all modifications are inspected and certified, ensuring compliance and recorded in the COF database.

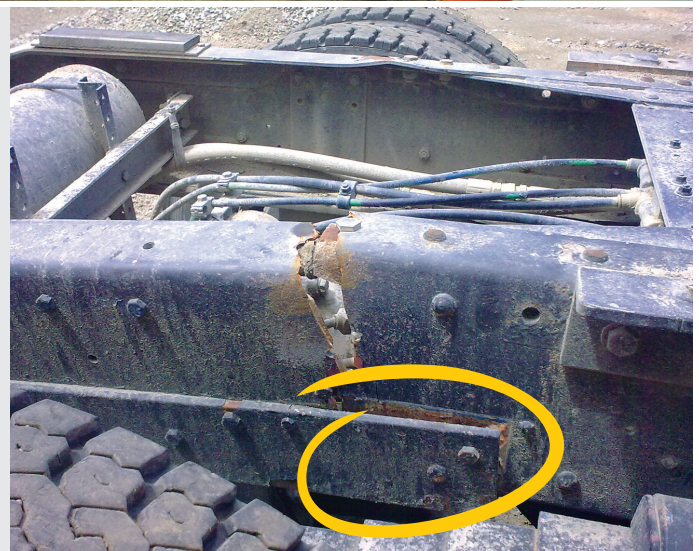
The investigation identified that the six wheeled truck was once a tractor unit and had been modified into a tip truck. The picture at right clearly shows that the chassis strengthening finishes prior to the third axle, which carries most weight when tipping or spreading material.

The insurance assessors report identified that while the original chassis and suspension specification were adequate for a tractor unit it was below spec for tipper work.

The identified hazard is the modification of the tractor unit chassis which had been converted to a tipper truck.
