INCIDENT ALERT

LOCATION:	ROAD TRANSPORT	ALERT STATUS:	Normal
ACTIVITY:	MAINTENANCE & HOUSEKEEPING	DATE ISSUED:	09/05/2011
SUB ACTIVITY:	N/A	INCIDENT No:	00289

Potential Mixer Drum Entanglement

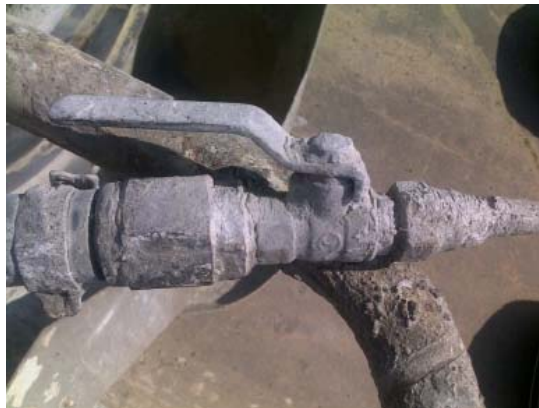
Mixer Tap

A serious incident occurred recently during the washing down of a mixer drum following discharged concrete. It is believed that the cause of this incident was the type of tap (see picture).

The design of the tap, and dependant on where an individual washes the blades, could result in the tap becoming wedged in the mixer blade, pulling the hose and potentially the individuals hands/arm into the mixer.

These types of taps should be replaced with twist on/off taps.

Mixers should only be washed in discharge mode.

All 'guarding' of mixers should be assessed to ensure that it is adequate if a hose should become trapped.
