Rubber Capping Test Equipment

NZRMCA Technical Note 4

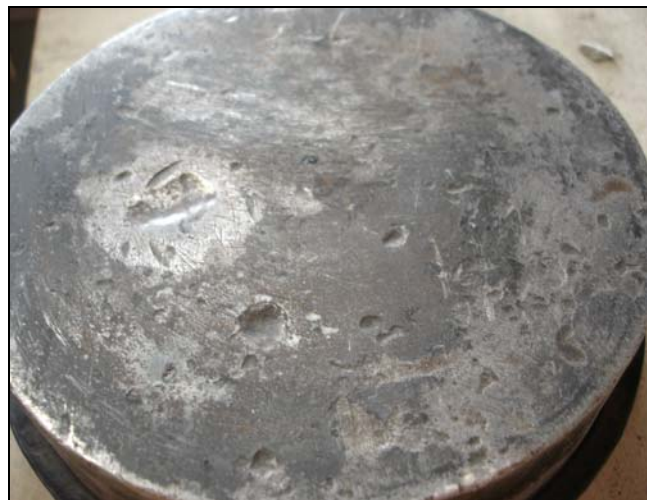
Many users are reporting serious pitting of the metal sub platen assembly of these rigs.

A piece of equipment was tested at Canterbury University and the results showed that the sub platen had a **Rockwell B** surface hardness of between **70-80**. This is significantly lower than specification recommendations normally needed for a sub platen assembly.

Such testing equipment needs to have a Rockwell C surface hardness of 55.

The deterioration of the sub platen surface can start to influence the strength results being obtained. The speed with which the surface deteriorates is directly related to the surface hardness of the equipment.

1. When ordering any new equipment, make sure the equipment specification includes the requirement for the bearing surface to have a C55 Rockwell Hardness.
2. When pitting becomes extensive (see photograph) consideration should be given to having the existing sub platens machined and surface hardened.
