<b>INCIDENT CLASSIFICATION:</b>	Motor Vehicle Accident - Whangarei FB JobSAFE ID: 192967
---------------------------------	---

<b>WHEN:</b>	4 <sup>th</sup> February 2011
<b>WHERE:</b>	708 State Highway 14, Maunu, Whangarei

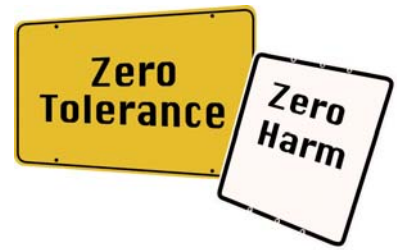
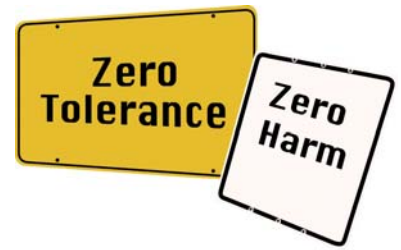
<b>WHAT HAPPENED:</b>	<p>On Friday 4<sup>th</sup> February an on-call driver was requested to work and reported to the Hewlett St, Whangarei Certified Plant. The driver picked up a truck at 5.40am and proceeded to the Dargaville Certified Plant to assist with a large concrete pour (167.8m<sup>2</sup>). The driver had completed his seventh and final delivery to the customer site and on return to Dargaville refuelled his truck and commenced the drive back to Whangarei. At approximately 4.20pm the truck left the road and struck a stone wall followed by a power pole which resulted in the truck rolling onto the driver's side and the driver being trapped in the cab. Power lines were down over the truck and power had to be isolated before rescue services could commence extrication. The driver sustained a compound fracture to the lower left leg.</p>  
-----------------------	---

<p><b>FINDINGS:</b></p>	<p>The driver had not worked previously that week however had worked 10.5 hours without having an uninterrupted half hour break.</p> <p>Maximum temperature on the day was over 27° with a high level of humidity.</p> <p>The truck had a current COF however there was no pre-start inspection conducted on this truck prior to start that morning.</p> <p>The driver has admitted “dozing off” just prior to the incident.</p> <p>There is no evidence that the driver has been inducted nor re-inducted in the past 12 months.</p>
<p><b>IMMEDIATE ACTION</b></p>	<ul style="list-style-type: none"> <li>• All drivers must be inducted annually. Ensure this has been undertaken by the end of March.</li> <li>• All drivers to have attended refresher logbook training in the past 12 months.</li> <li>• Firth will be developing a Fatigue Management Plan which will be communicated to all personnel in due course.</li> <li>• The addition of Fatigue as a Generic Significant Hazard will be added to the Hazard Register.</li> <li>• All drivers must take their ½ hour break after 5 ½ hours continuous work. This break may be taken prior to the 5 ½ hours. NO EXCEPTIONS. DO NOT LOG YOUR BREAK AND HAVE IT LATER. This is able to be monitored via the Status Automator system and is considered as serious misconduct if your logbook detail is not accurate.</li> </ul> <p>THIS H&amp;S ALERT TO BE DISCUSSED AT HEALTH &amp; SAFETY MEETING ON THE 8<sup>th</sup> or 9<sup>th</sup> March 2011</p>
